IFCA-G-014
Valencia, CA 91355
Fax: (818) 291-0339
Web: www.hyetechllc.com

6888529HT Starter Generator Spur Gear Shaft

Subject: Removal, cleaning, inspection, rework, repair, and installation procedures for 6888529HT-Starter Generator Spur Gearshaft

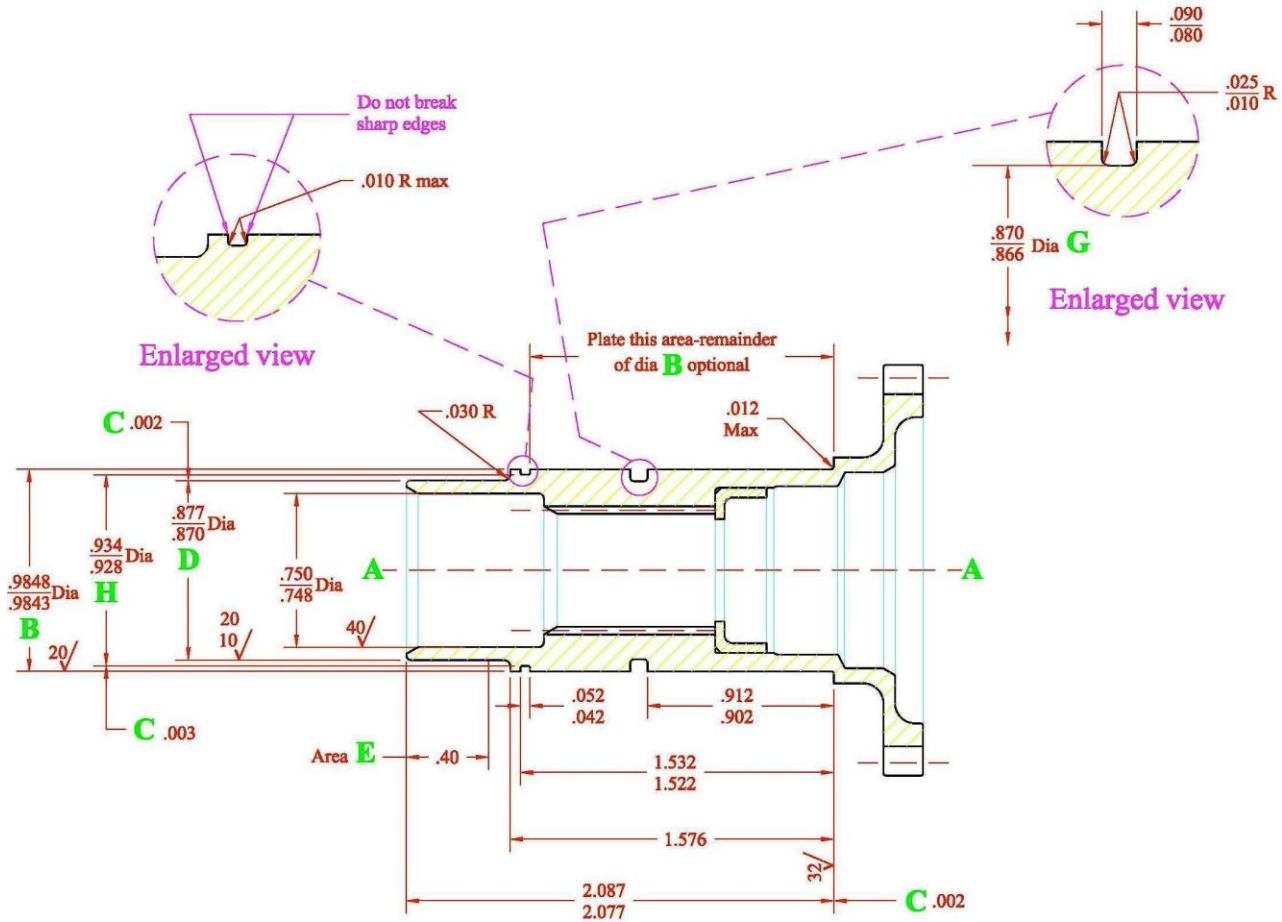
Figure 1: Starter Generator Spur Gearshaft

Axis **A-A** established by dia. **B**

Features shall be concentric & square about axis **A-A** within the TIR specified by **C**

Surface lay in area **E** of dia. **D** shall be annular & free from longitudinal & spiral tool marks

- 5.4 Grind the bearing or seal journal to remove any roughness or previous plating if no other surface preparation is specified in the inspection tables. Maintain concentricity requirements in accordance with Figure 1.

- 5.9 Finish grind the plated journal in accordance with Figure 1. Concentricity and finish requirements must be met. There must be no spiral lead in the finish on seal journals.
